# **DORROUGH ELECTRONICS**

## POWER SUPPLY UPDATE SHEET FOR THE DISCRIMINATE AUDIO PROCESSOR

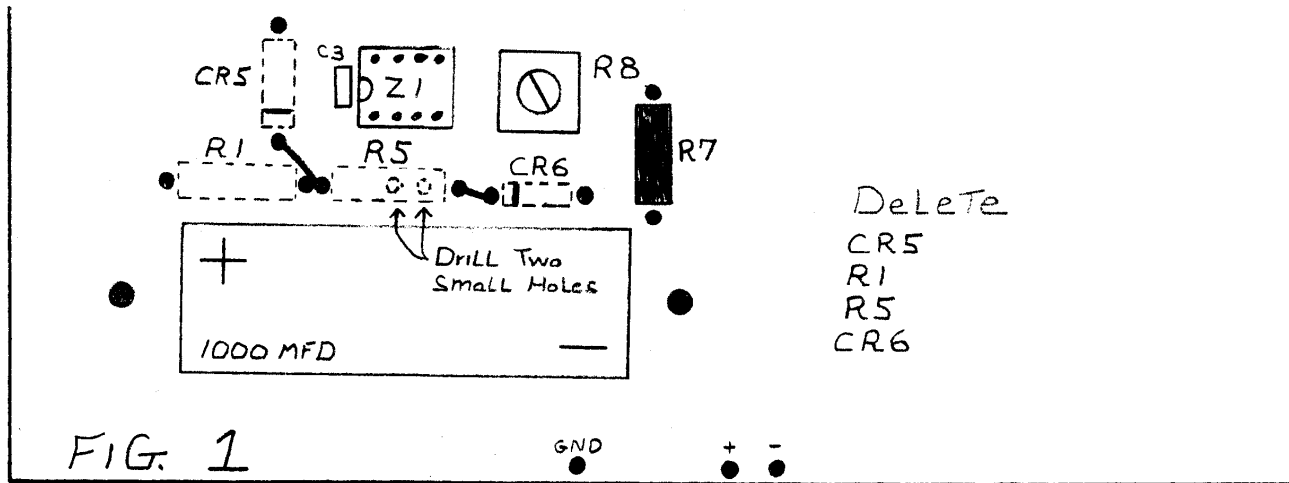
Drill two small holes approximately 2/16 inches in diameter in line with the old junction of R5 and CR6 (see Fig. 1) approximately 1/8 inch center to center.

Remove the old reference components by lifting the power supply and unsoldering components R1, R5, CR5, and CR6.

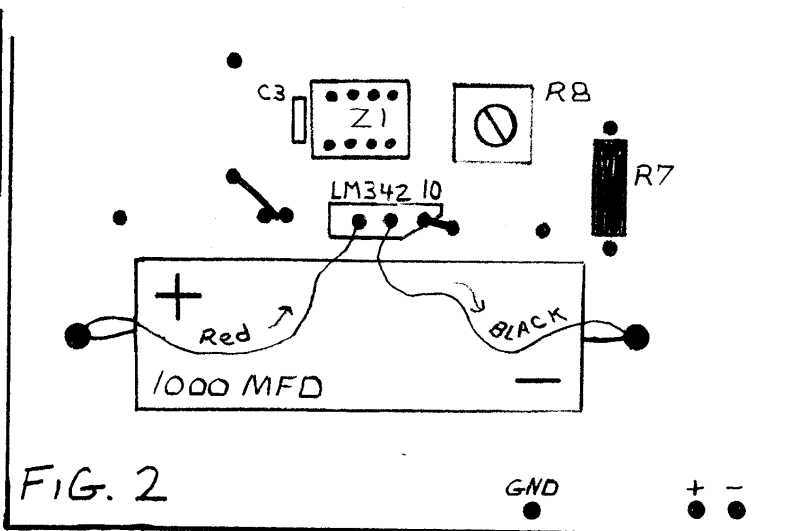
Install the device with the chamfer on the face towards C1 (see Fig. 2). This is important as it orients the pins for correct assembly.

Note: The pin below the chamfer is the regulator output. It should go into the hole vacated by R5 at the R5, CR6 junction. If incorrect assembly occurs, the power supply will not be damaged.

1. Using black 24 AWG insulated buss wire, jumper the center pin to the negative side of C1.

2. Using red 24 AWG insulated buss wire, jumper the pin closest to the front of the DAP to the plus side of C1.
3. Solder the pin on the chamfered side to the old R5, CR6 pad (leading to Z1 pin 3).
